# EU DISTRICT – RESULTS OF THE VISITS

## EU District Repositioning

March 2022

EU-occupied buildings only

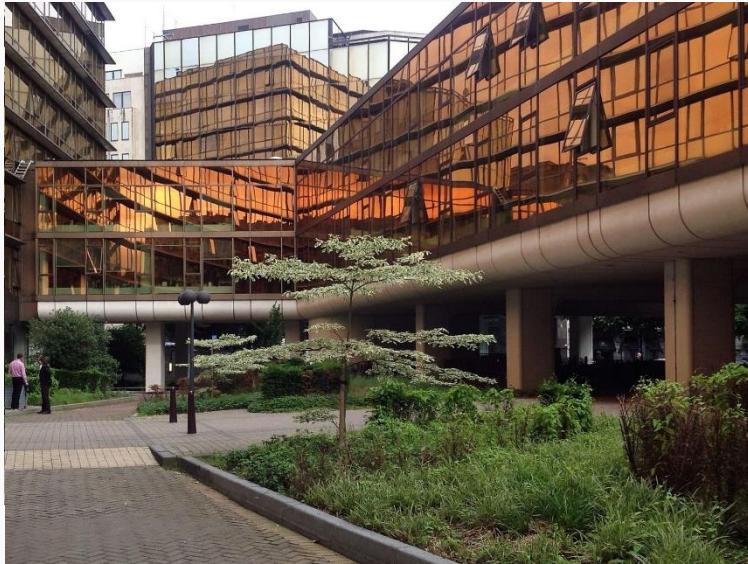
# Square de Meeûs 8

The building is likely to be vacated and will need to be completely renovated. Whilst it is surrounded by a large green area, this is sealed off with fencing, planting, and leveling. There is significant potential to integrate the plot into the wider neighborhood.

The building's fully glazed ground floor and surrounding gardens offer a unique opportunity to integrate this plot into its urban context.

Any renovation will need to address how to manage the building perimeter to make it more accessible, visible, and transparent to the neighborhood.

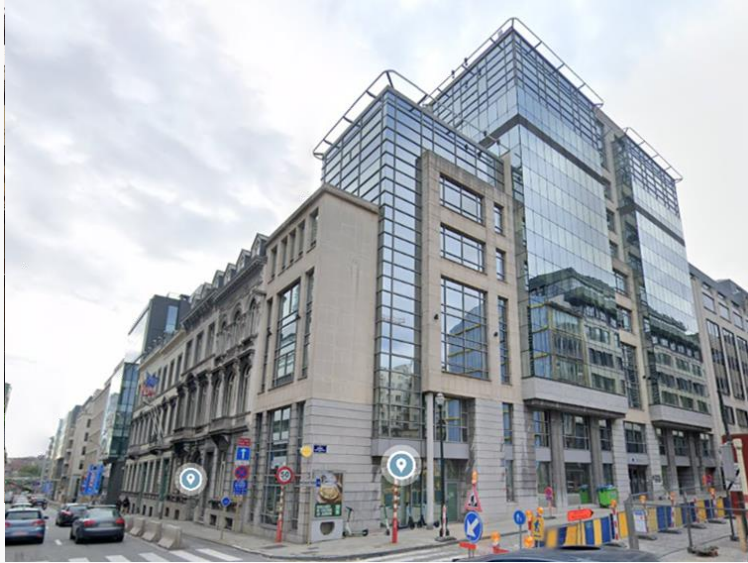
# Science 11

The building's façade glazing is blocked with vertical blinds. Roof greening potential is probably limited. Lack of visitor soft mobility access.

Like for most of the EU buildings, the reception area could be redesigned to be larger and more welcoming offering some extra facilities for staff and generating visual interaction with the street level.

Blinds and stickers should be removed from the ground floor façade.

A convenient solution for soft mobility visitors needs to be worked out potentially via an enlarged reception area.

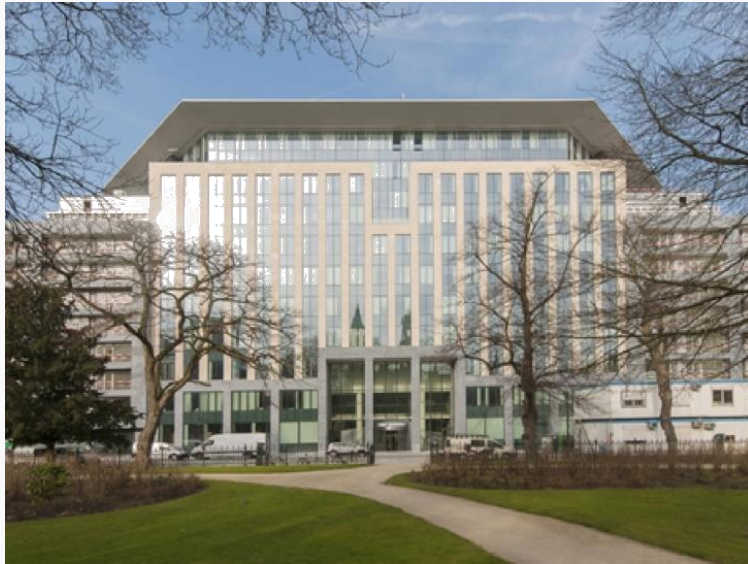
# Square Frère Orban 8 (Espace Orban)

The building has a ground floor façade blocked with stickers and blinds. It also has a major mineral inner courtyard that could be greened or even made accessible to the public.

Like all other EU buildings, stickers and blinds should ideally be removed.

A more convenient visitor bike parking solution needs to be found.

The building has a very large courtyard that could be activated with a catering option and made greener with some landscaping.

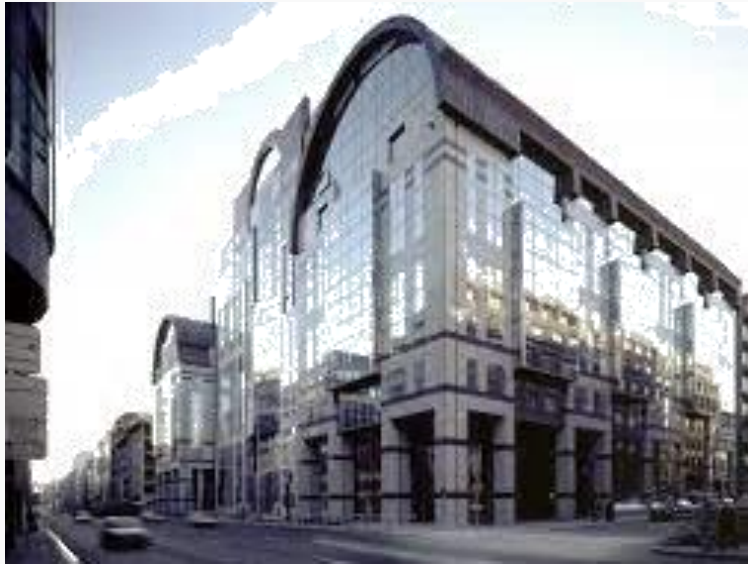
# Loi 41

The building has a completely opaque ground floor façade due to stickers. It has a major inner courtyard as well as a roof that has the potential for greening.

Like all other EU buildings, stickers and blinds should be removed ideally. A more convenient visitor bike parking solution needs to be found.

The building has a very large courtyard that could be activated with a catering option and rendered greener with some landscaping.

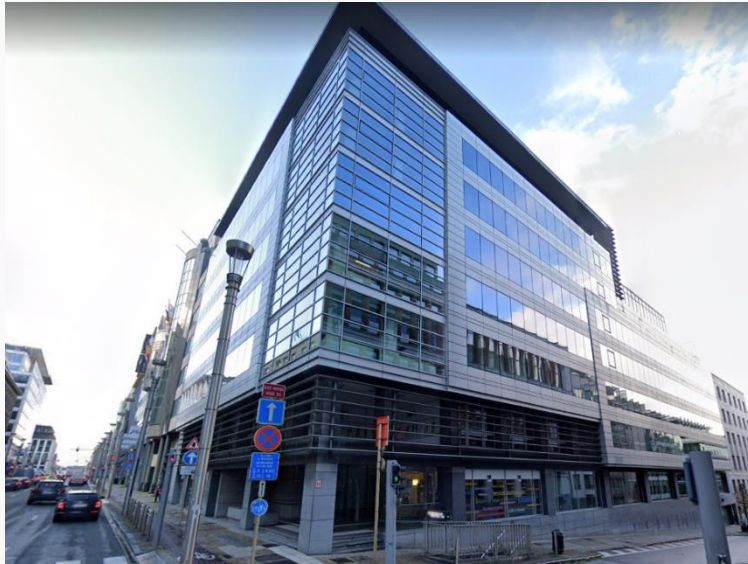
# Loi 56

The building's façade glazing is blocked with stickers and blinds. Otherwise, the building has a partly green roof and courtyard.

As for all other EU buildings removing stickers and blinds should be a priority. Finding a solution for biking visitor's access. The ground floor could be activated or made more interactive with semi-public functions.

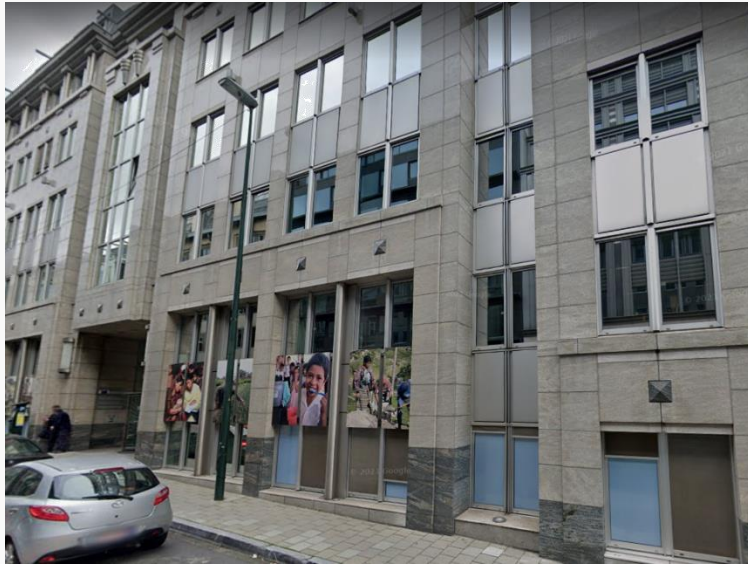
# Joseph II 54

The building is part of a major group of EU-occupied buildings. The block has an incredible garden and massive green roof terrace, none being accessible to anyone. The façade is completely blocked with panels and vertical blinds.

The building has a very nice inner garden that is not accessible either for EU staff or externals. The huge landscaped roof terraces have intensive landscaped greening but are not accessible.

As for all EU-occupied buildings, removing stickers and finding a convenient soft mobility visitor parking solution are priorities.

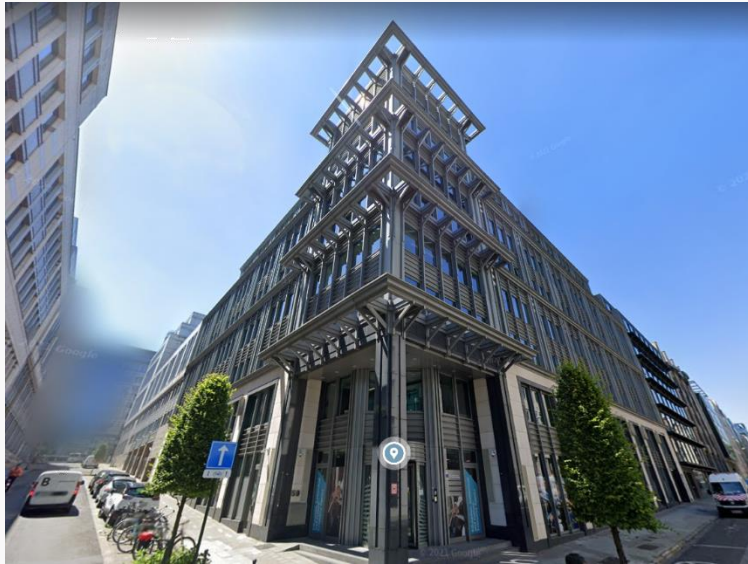
# Joseph II 59

The building has a completely opaque ground floor façade with stickers and blinds. The roof and terraces have the potential for greening.

As for all EU-occupied buildings, removing stickers and finding a convenient soft mobility visitor parking solution are priorities.

In addition, the building roof and terraces have the potential to be greened or used for solar panels.

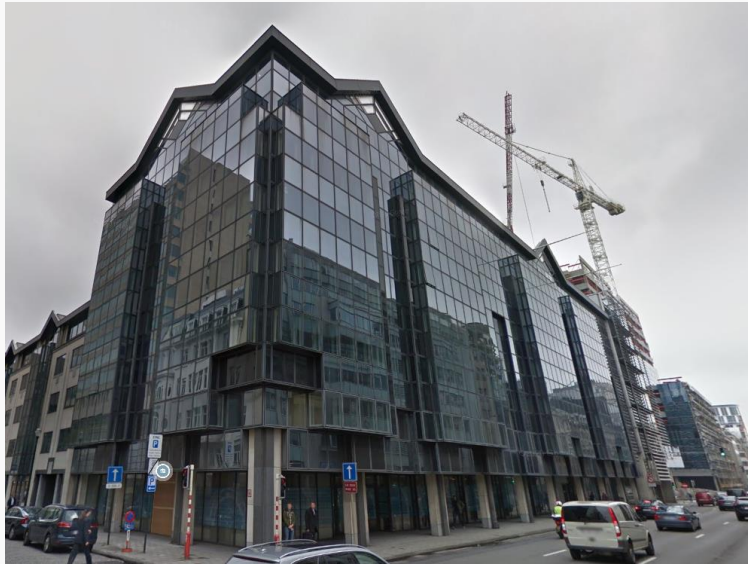
# Belliard 24-28

The building has a glazed but completely blocked ground floor façade with stickers. Access for soft mobility visitors is difficult. The roof can likely be greened.

As for all EU-occupied buildings, removing stickers and finding a convenient soft mobility visitor parking solution are priorities.

In addition, the building roof could be partially greening or used for solar panels.

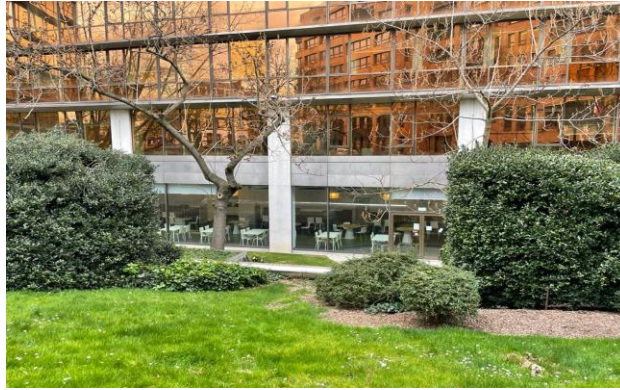
# Square de Meeûs 8

Transparency estimated potential: **50% (150m)**

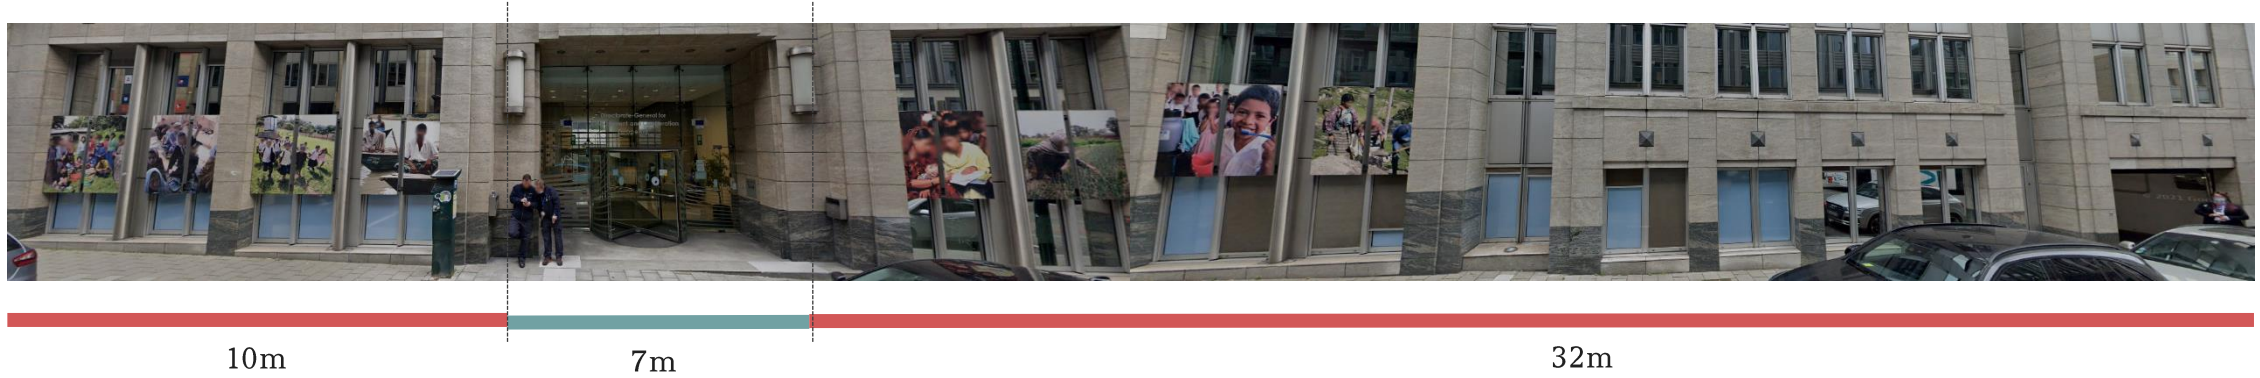
# Joseph II 54

Transparency estimated potential: **86% (42m)**
