# EU DISTRICT – RESULTS OF THE VISITS

## EU District Repositioning

March 2022

EU-occupied buildings only

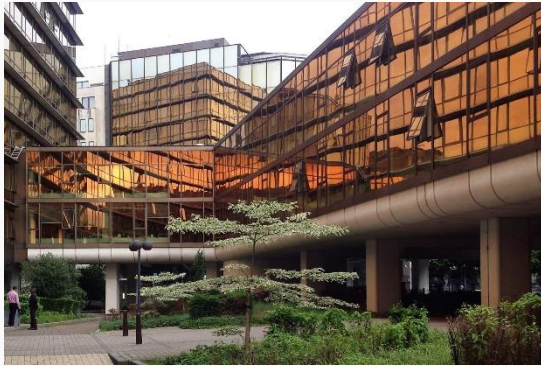
## Square de Meeûs 8

The building is likely to be vacated and will need to be completely renovated. Whilst it is surrounded by a large green area, this is sealed off with fencing, planting, and leveling. There is significant potential to integrate the plot into the wider neighborhood.

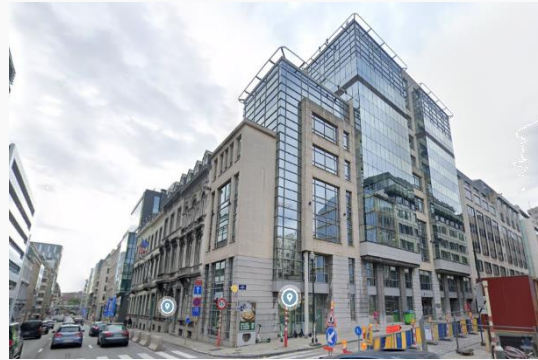
## Science 11

The building's façade glazing is blocked with vertical blinds. Roof greening potential is probably limited. Lack of visitor soft mobility access.

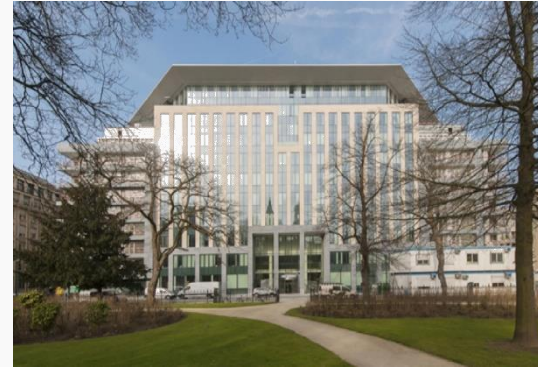
## Square Frère Orban 8

The building has a ground floor façade blocked with stickers and blinds. It also has a major mineral inner courtyard that could be greened or even made accessible to the public.

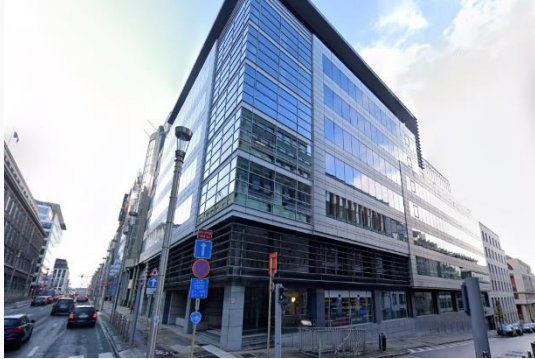
### Loi 56

The building's façade glazing is blocked with stickers and blinds. Otherwise, the building has a partly green roof and courtyard.

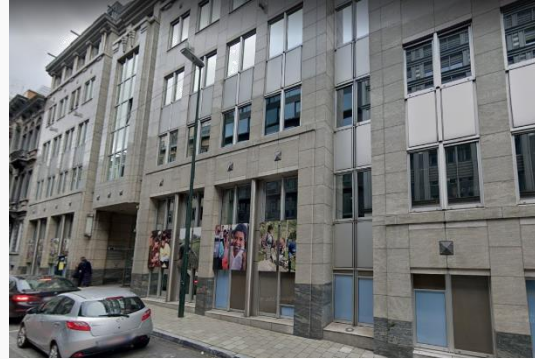
### Joseph II 54

The building is part of a major group of EU-occupied buildings. The block has an incredible garden and massive green roof terrace, none being accessible to anyone. The façade is completely blocked with panels and vertical blinds.

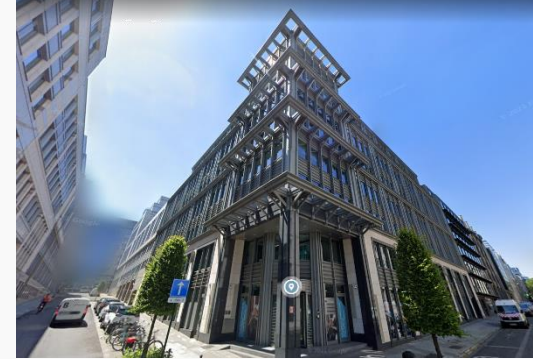
### Joseph II 59

The building has a completely opaque ground floor façade with stickers and blinds. The roof and terraces have the potential for greening.

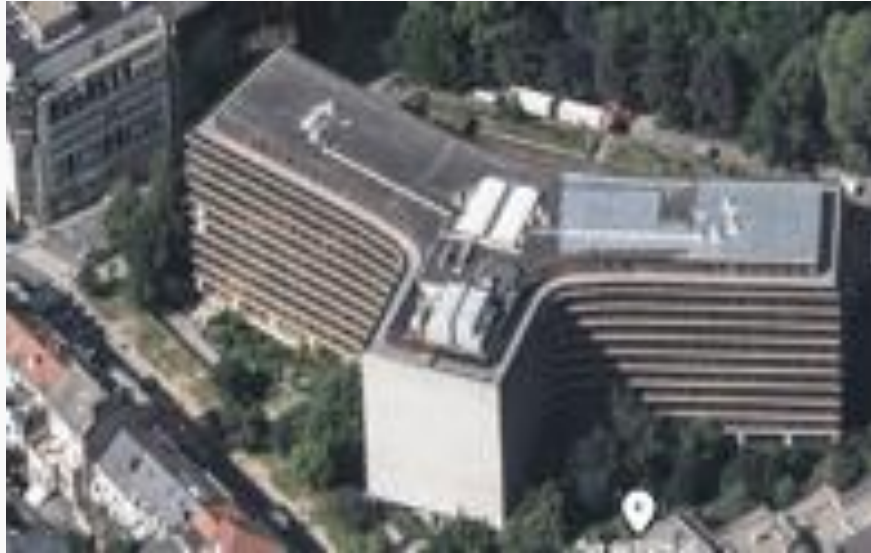
Estimated roof surface: 3,662 sqm

Potential activation area for greening: **1,374 sqm (38%)**

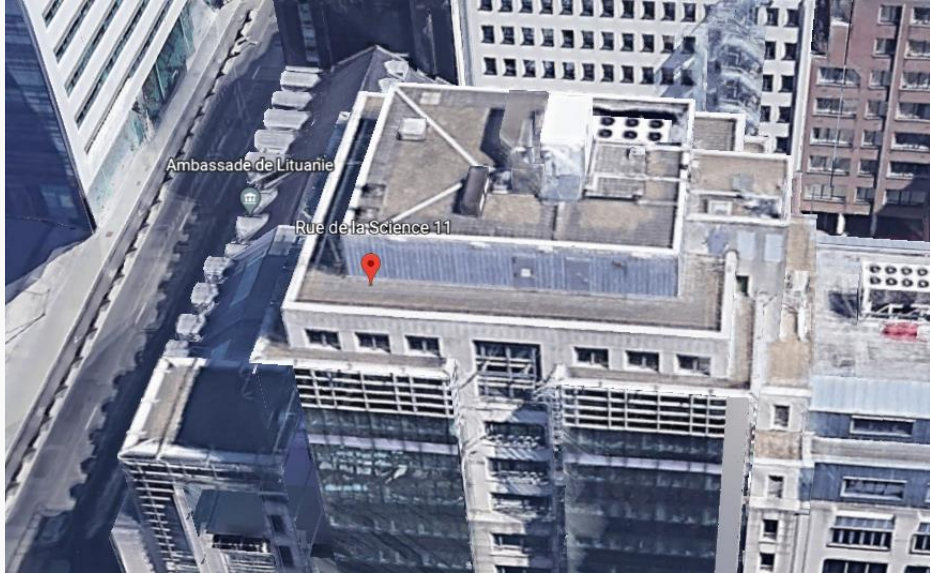
Estimated roof surface: 875 sqm

Potential activation area for greening: **675 sqm (77%)**

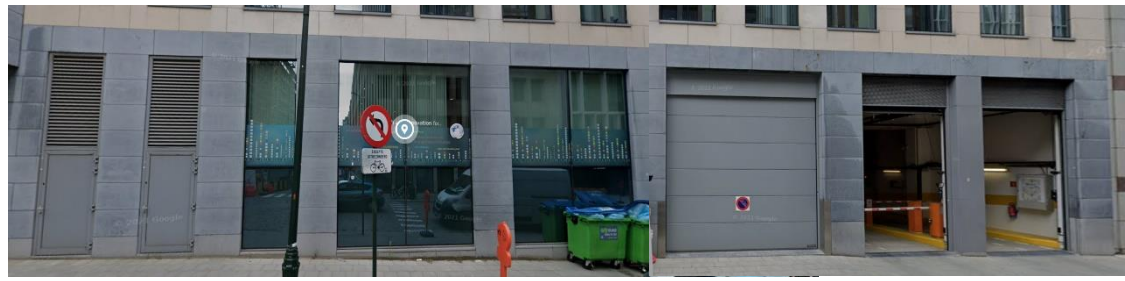
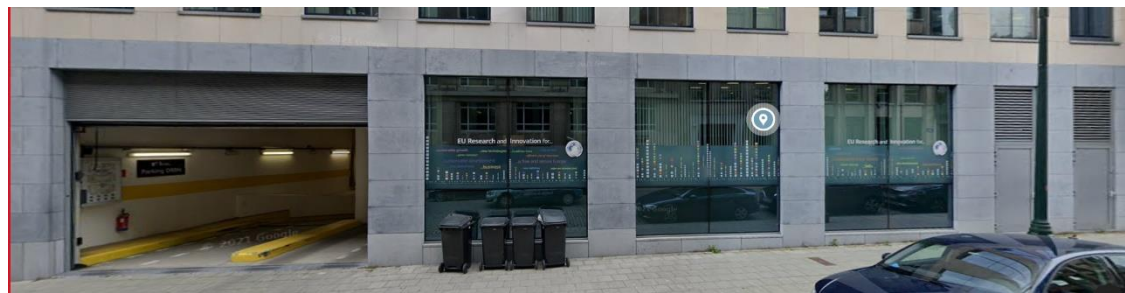
5-9-13m

9-13-5m

Transparency estimated potential: **79% (54m)**

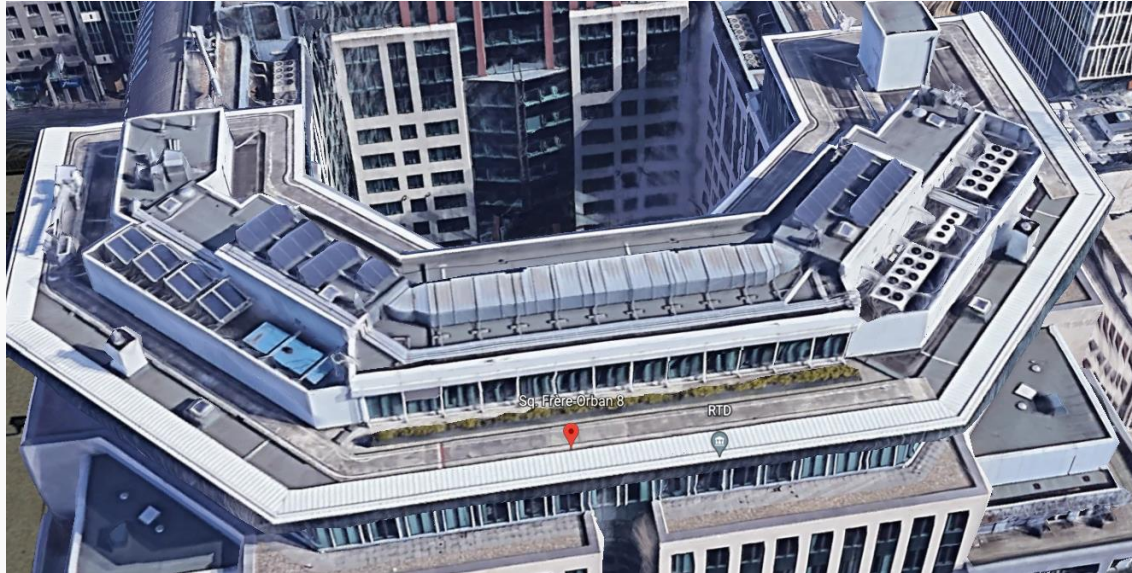
## 2. Green and public spaces

Estimated roof surface: 4,425 sqm

Potential activation area for greening: **none (0%)**. Circa 1,000 sqm is already greened

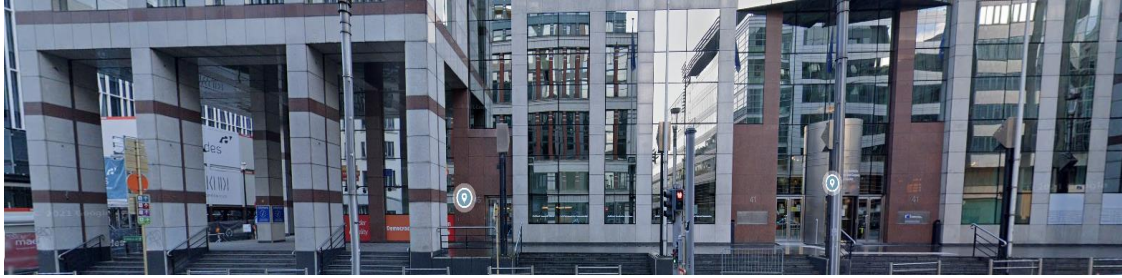
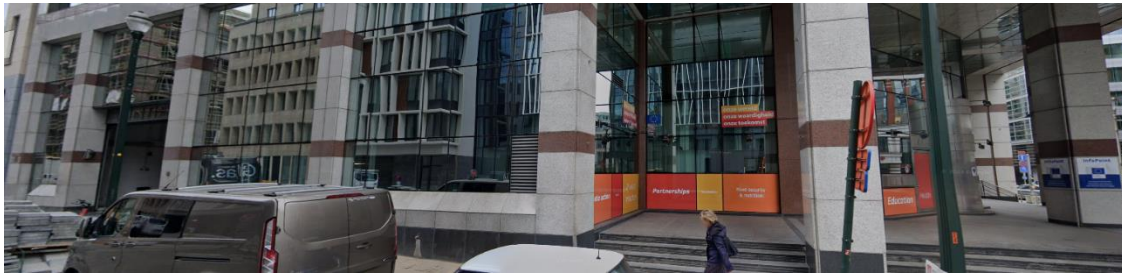
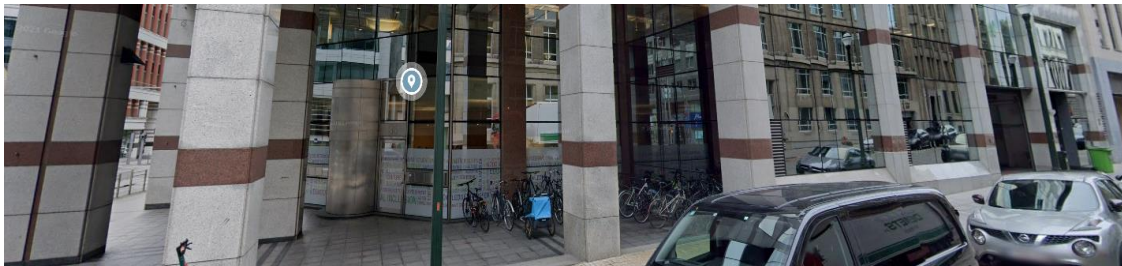
## 1. Ground floor activation

80m

10-37m

41-6m

Transparency estimated potential: 100%  
(158m)

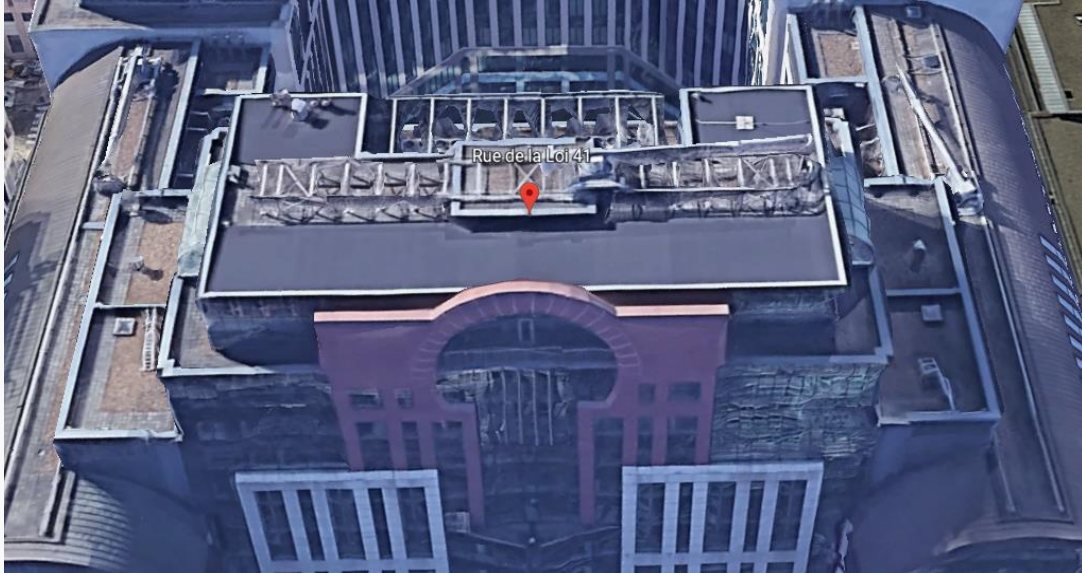
## 2. Green and public spaces

Estimated roof surface: 3,041 sqm

Potential activation area for greening: **600 sqm (20%)**

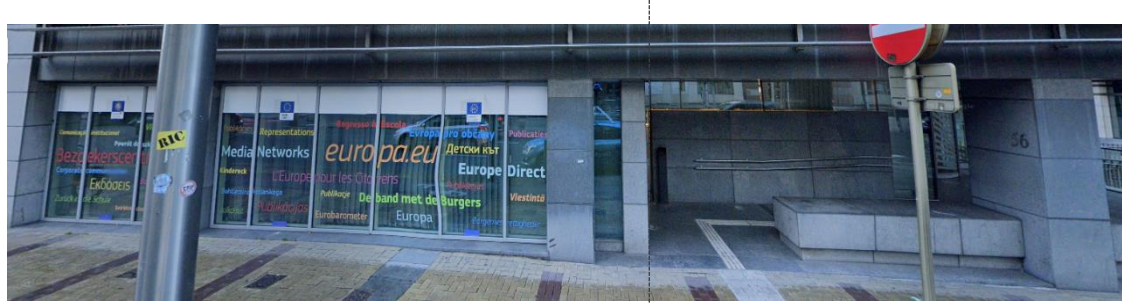
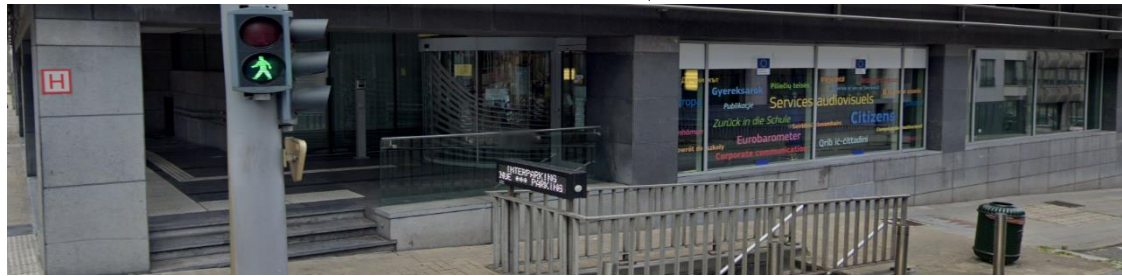
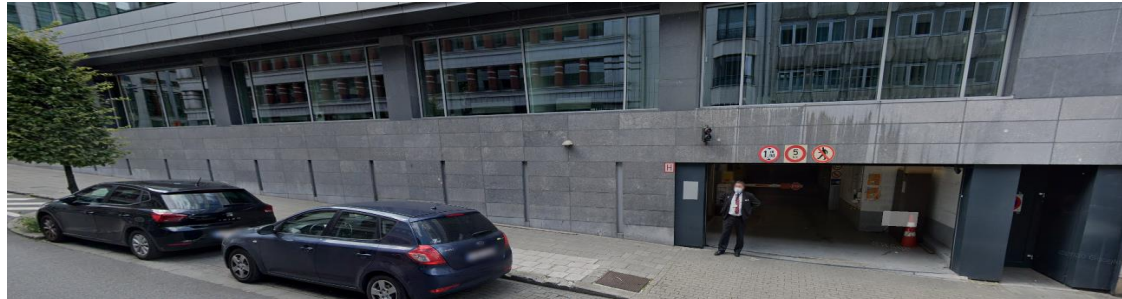
## 1. Ground floor activation

13-10m

16m

40m

Transparency estimated potential: 100% (69m)

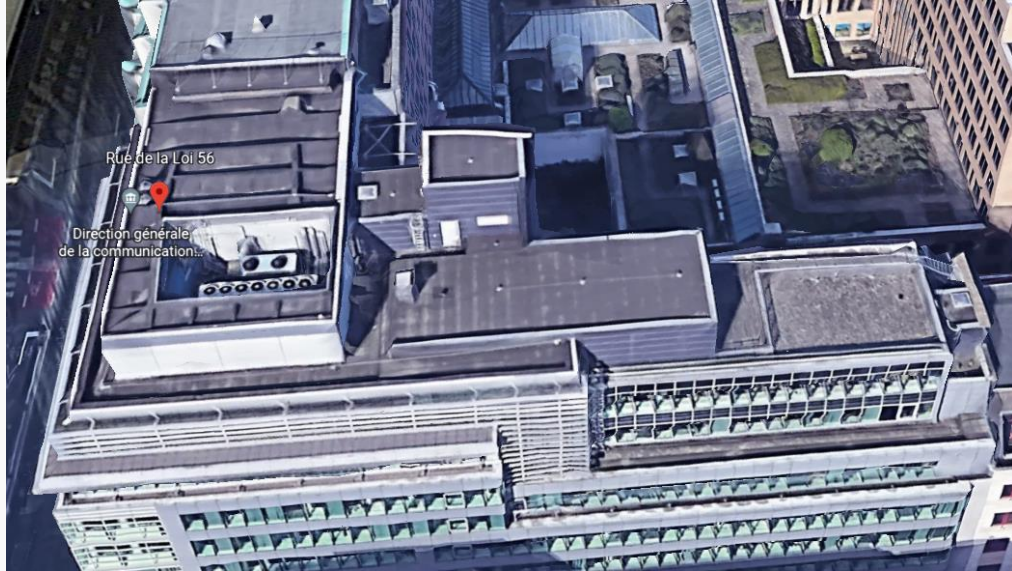
## 2. Green and public spaces

Estimated roof surface: 1,325 sqm

Potential activation area for greening: **500 sqm (38%)**

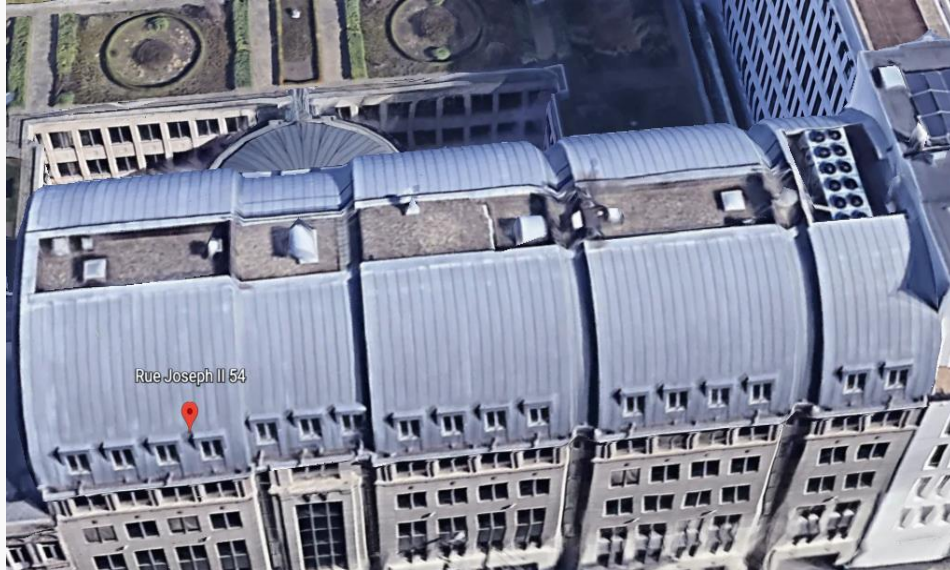
## 2. Green and public spaces

Estimated roof surface: 1,100 sqm

Potential activation area for greening: **none (0%)**. Pitched roof

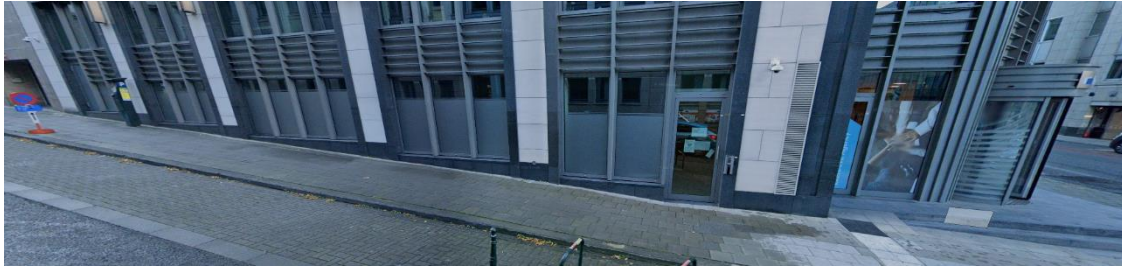
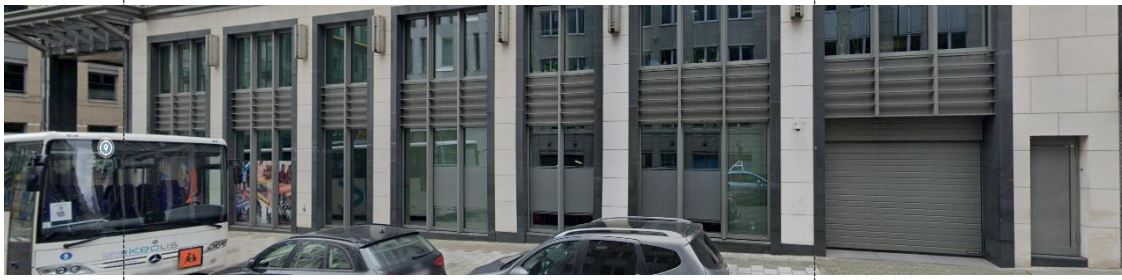
## 1. Ground floor activation

31m

7m

23m

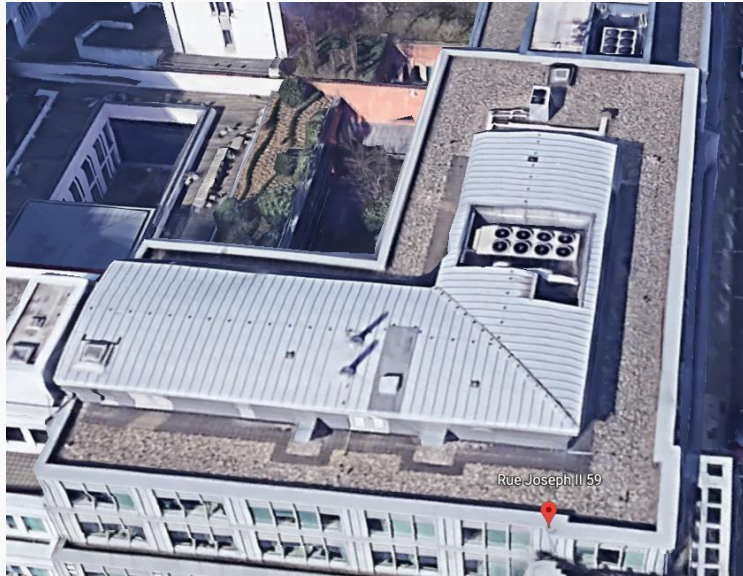
## 2. Green and public spaces

Estimated roof surface: 1,270 sqm

Potential activation area for greening: **650 sqm (51%)**

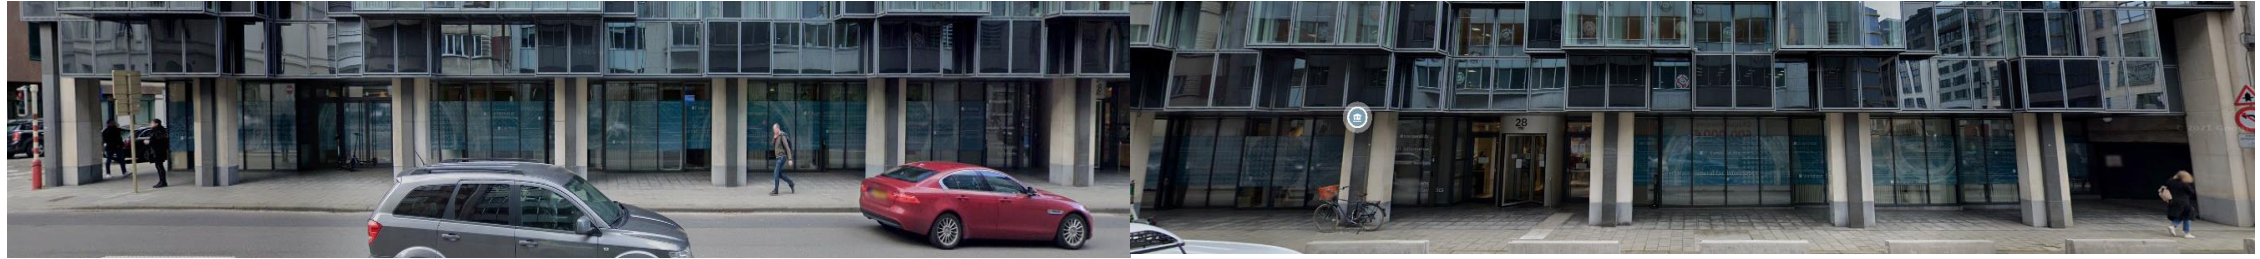
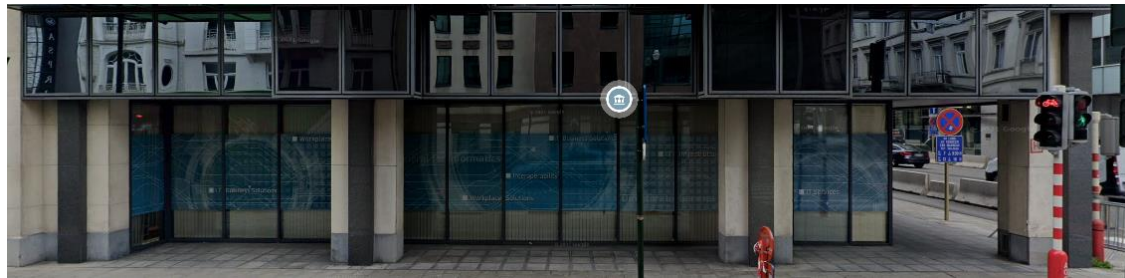
## 1. Ground floor activation

65m

20m

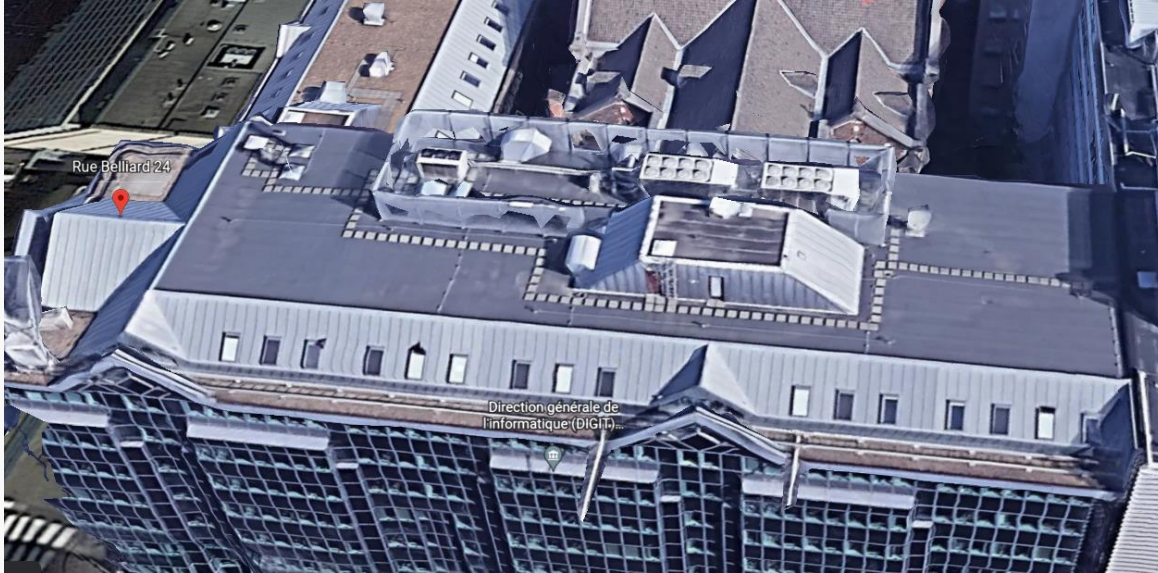
## 2. Green and public spaces

Estimated roof surface: 2,770 sqm

Potential activation area for greening: **1,036 sqm (37%)**
